# Manhole Inspection Summary

Manhole # S23K1\_001MH

Insp Date: **12/1/08 1:22 PM**

**Location** Address: **2903 Mallview Rd.**

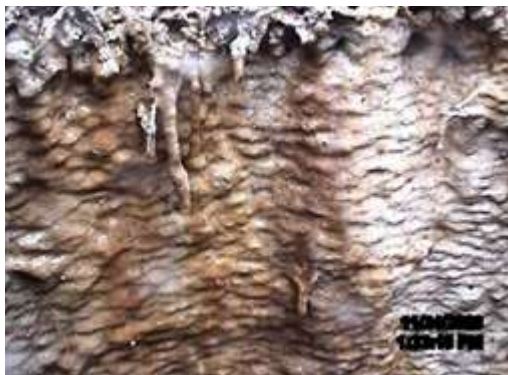
Defect 9

active chimney infiltration dripping down  
mineral build-up on corbel

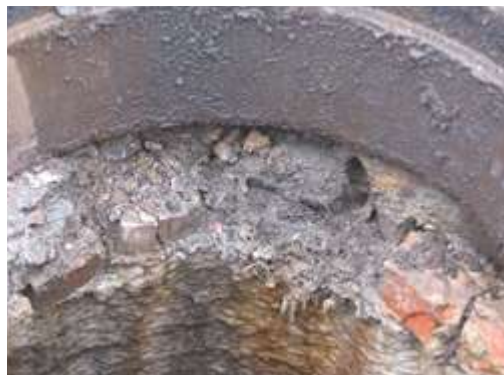
Defect 7

Condition: ☐ Sound ☐ Cracked ☐ Root Intrusion ☒ **Loose Brick** ☒ **Deteriorated**

Infiltration: ☐ None ☒ **Joint** ☐ Cracks ☒ **Mortar** ☐ Roots ☐ Wall

deteriorated chimney with infiltration

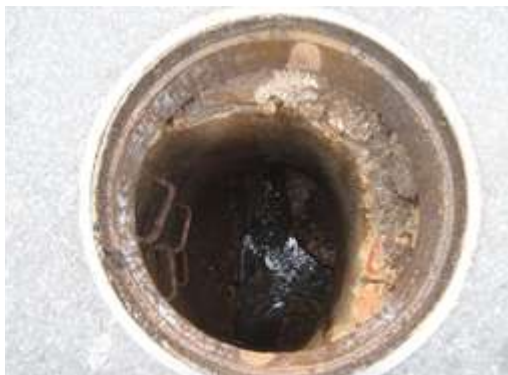
Defect 3

Offset: **4** (in.)

Count: **5** Missing: **0** ☒ **Corroded**

corroded steps and frame offset

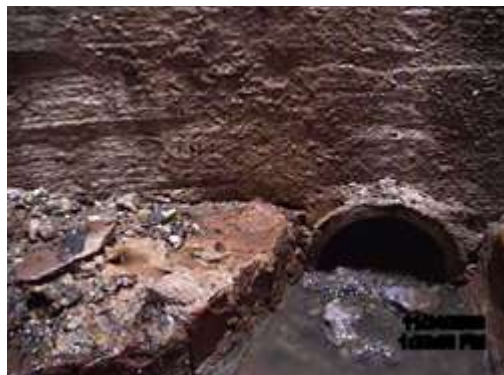
Defect 2

Infiltration: ☐ None ☐ Joint ☐ Cracks ☐ Mortar ☐ Roots ☒ **Wall**

barrel infiltration

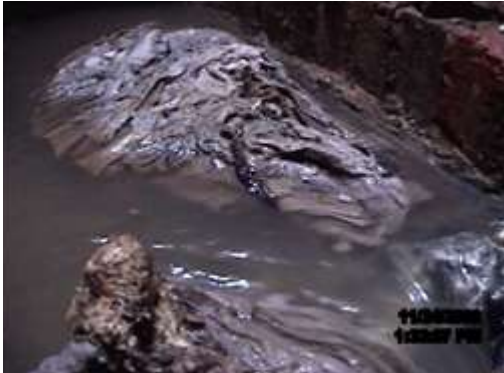
### Defect 1

Condition: ☐ Sound ☐ Cracked ☐ Root Intrusion ☐ Deteriorated ☐ Leaks ☒ **Debris**

debris in the channel

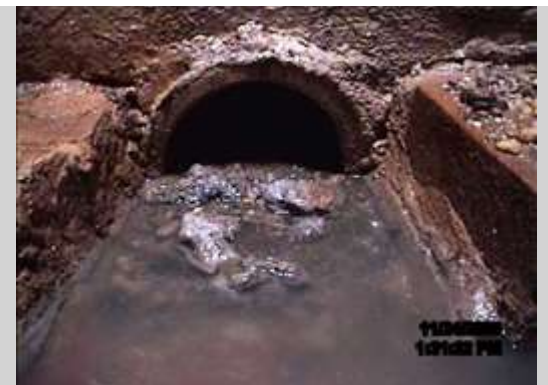
3 O'Clock Inflow

Pipe Height: **6** (in.) Rod and Bar (Angled)  
Pipe Material: **Clay** ☐ Pipe Lined  
Invert Depth: **9.59** (ft.) Flow Characteristics: **None**  
Deposits: ☐ None ☐ Mud ☐ Sludge ☒ **Debris** ☐ Grease  
Silt Depth: **4** (in.) Deposits Extent: **Medium**  
Infiltration: **None** Pipe Seal Cond: **Sound**
